SERVICE BULLETIN

AA-SB-28-002

Inspection & Rework of Fuel Shut-Off Mechanism

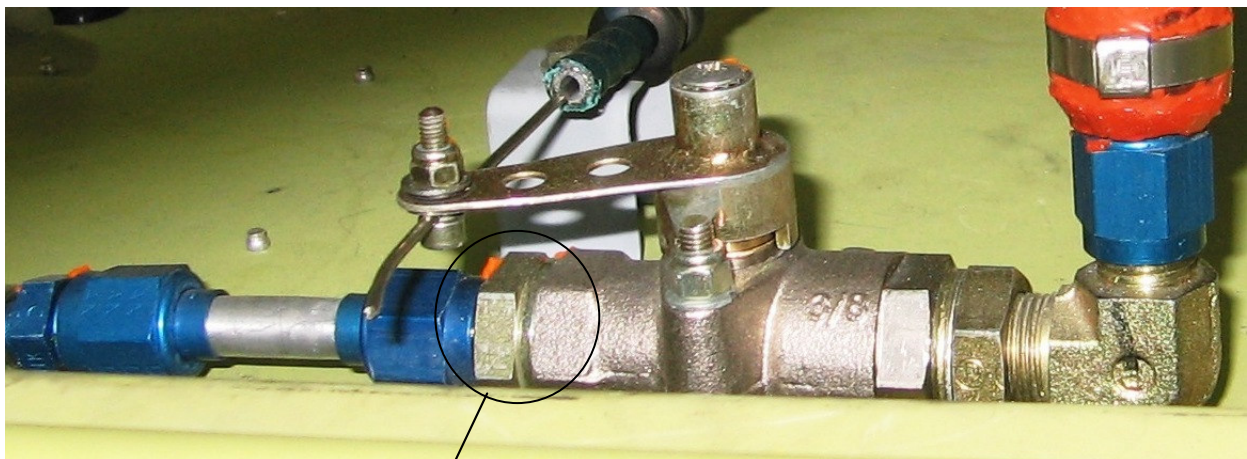
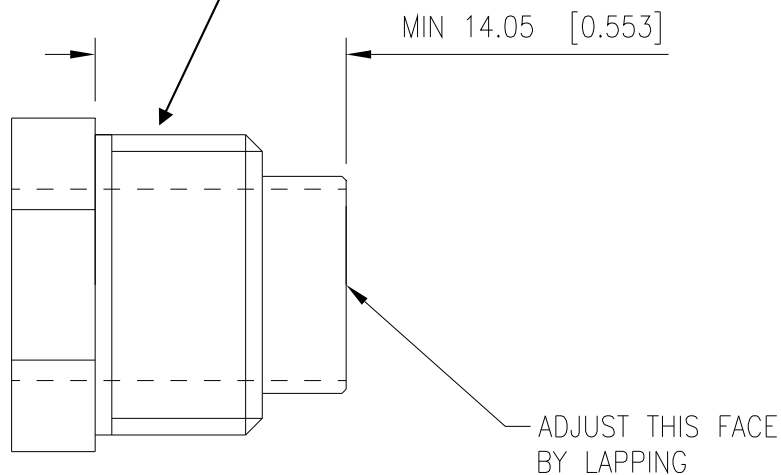
Allowable modification of the Inlet fitting
Fig 1

If the valve requires more than the 1 kg force to activate then it must be removed to investigate the cause. The valve may be recovered by carrying out the following action. Unscrew the inlet fitting to gain access to the pressure O ring and Teflon cup. Examine the ball valve, if scored the whole valve must be replaced.

Measure the distance between the inner face and shoulder of the inlet fitting. (See Fig 1) If this is more than 14.05 mm, then the inner face may be dressed to reduce the friction loads within the ball valve. Reassemble the valve and carry out the test as described above.
