SERVICE BULLETIN N° 13

Equipment concerned : Air intake, below carburetor

Aircraft concerned : All C.E.A. aircraft equipped with an air intake.

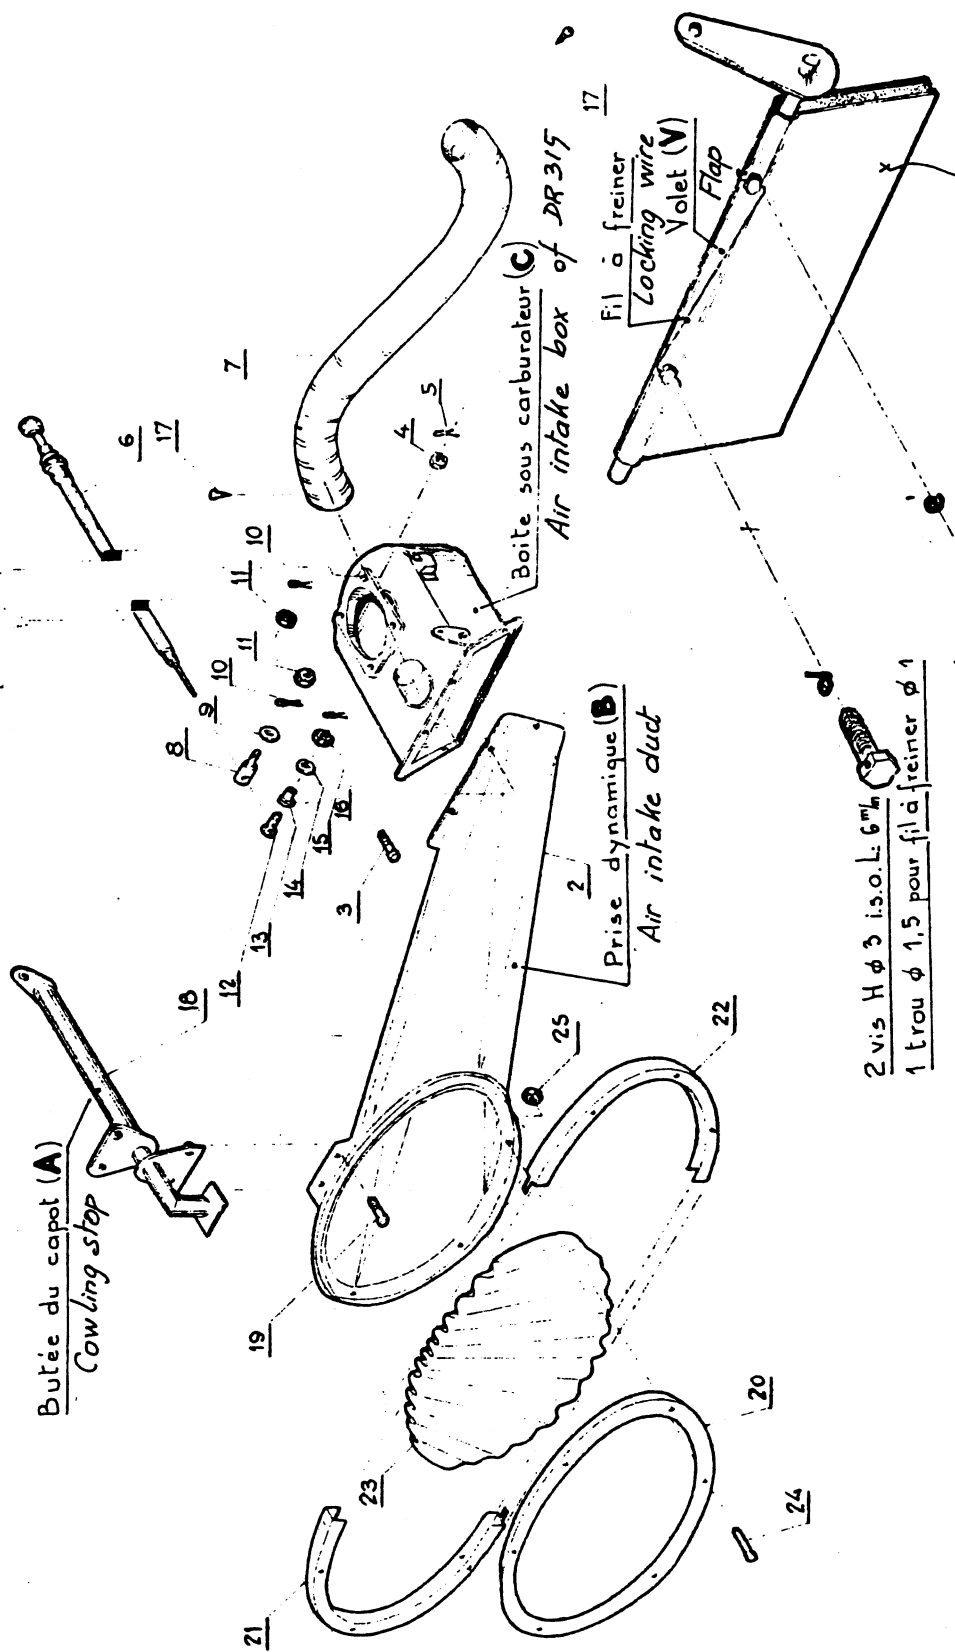
AVION DA ²⁵³ (cas n° 1)

The flap is secured to the shaft by means of round head screws which, in spite of the lock washers, may sometimes become loose.

2 iso H screws 3mm dia.
 x 6 mm
 1,5 mm hole for 1mm dia. lock. wire

To eliminate such risks, replace the round head screws by cheese head screws drilled to accommodate a locking wire. Lock the screws together with locking wire (see attached diagram, Case n°1).

- 1 - Remove top and bottom engine cowlings
- 2 - Remove the 2 bolts securing the air intake duct (B) to the lower cowling stop (A).
- 3 - Remove the 4 bolts securing the air intake duct (B) to the air intake box (C) (carb. heater).
- 4 - Remove the 2 screws (d and e) from the flap (V), as well as the lock washers.
Fit, instead, the 2 cheese head screws and washers. Lock both screws together with locking wire.
- 5 - Re-assemble the other components.

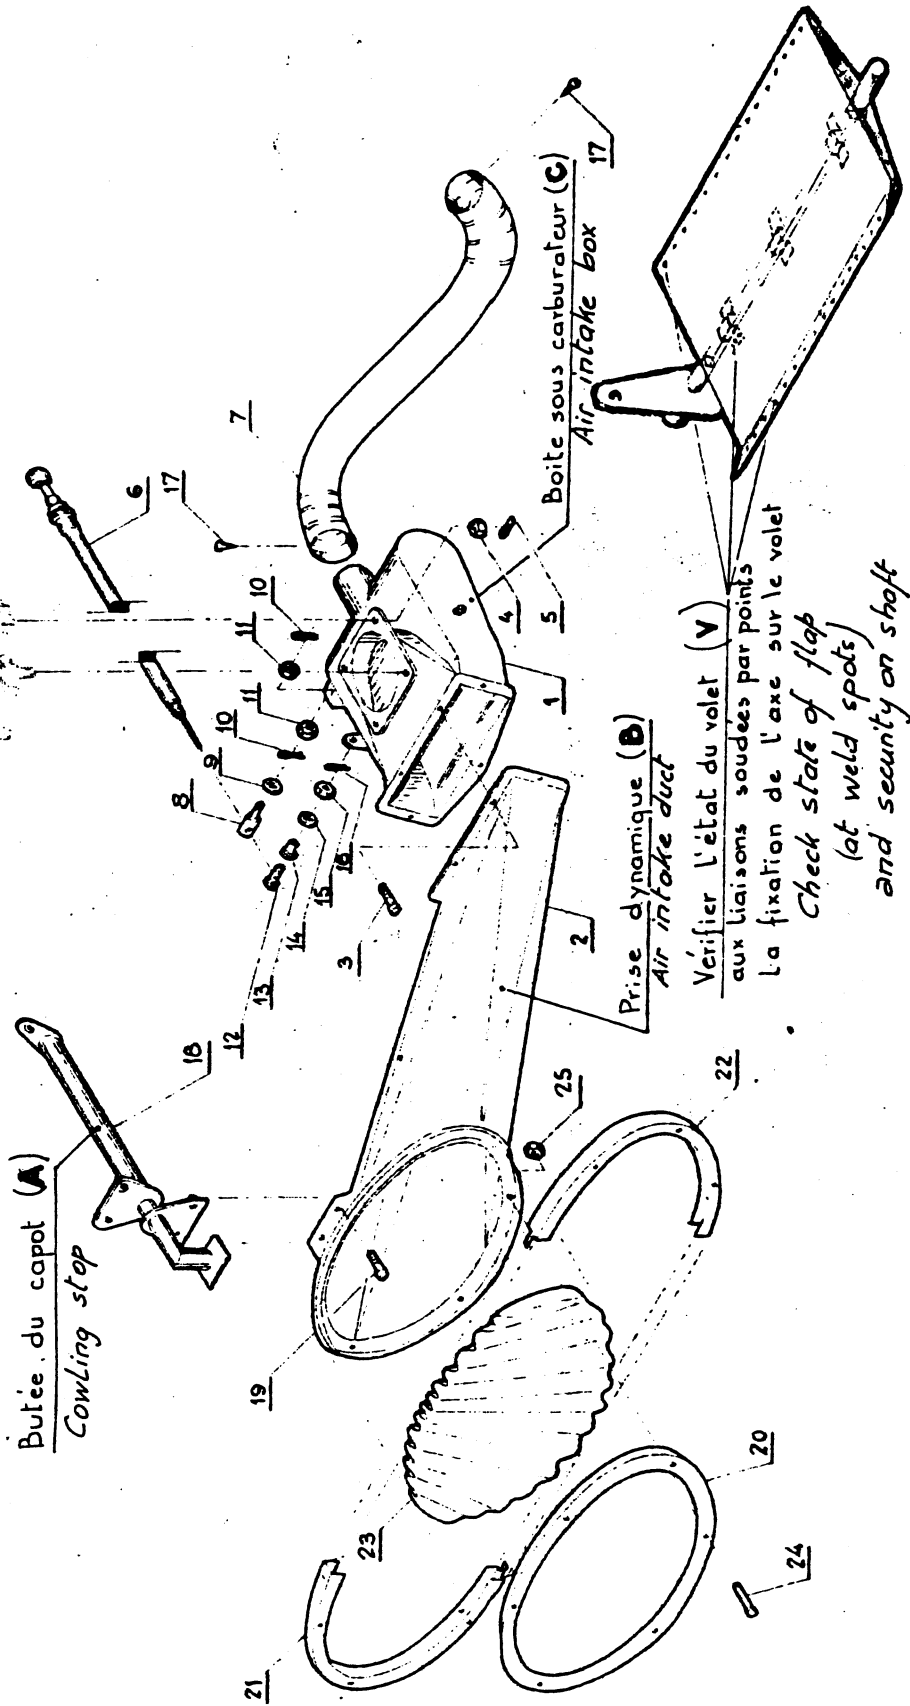
cas n°2

Vibrations may lead to the cracking, or even the parting, of the weld spots securing the top flap surface to the bottom surface (see attached disassembly procedure, Case n°2 and some examples of critical cases which necessitate the replacement of the air intake box).

- 1 - Remove control cables and conduits :
 - a) - carburetor butterfly control.
 - b) - carburetor heater control.
- 2 - Remove the Parker screw securing the flexible heater duct to the air intake box (C).
- 3 - Cut the 1 mm dia. locking wire securing the 2 1/4" dia. screws inside the air intake box (C).
- 4 - Remove the 2 1/4" internal screws.
2 external nuts
- 5 - Remove the assembly, taking care not to damage the gasket.

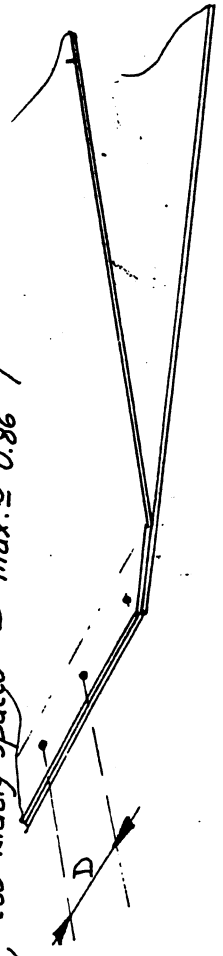
Point trop faible et trop écarté

Distance D maximum ≈ 23 mm

(Weak spot, too widely spaced "D" max. ≈ 0.86 ")

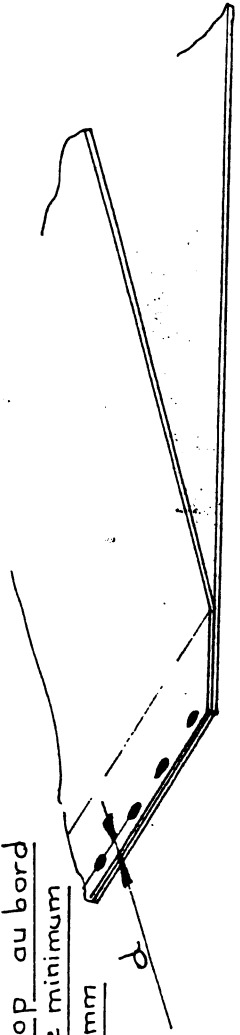
Point trop au bord

d = distance minimum

= 2 mm

(Spot too near the edge d. mini : 0.078")

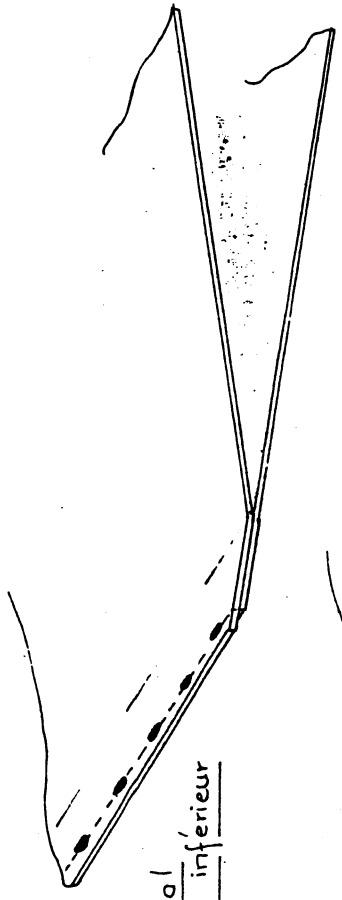
Point à cheval sur le volet inférieur

(Spot on edge of lower flap surface)

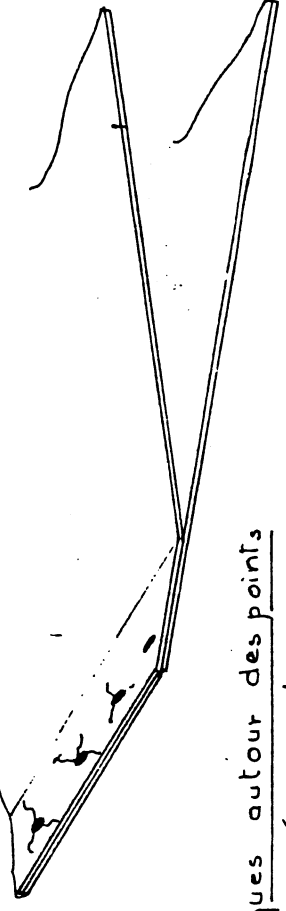
Crises autour des points

(Cracks)
