APEX Aircraft Bureau de Navigabilité 1, route de Troyes 21121 DAROIS - France Tél +33 380 35 65 10 Fax +33 380 35 65 15 www.apex-aircraft.com	<h1>SERVICE BULLETIN</h1> <p>No. 020714</p>
HR200 – Assembly of the aileron rod on the bellcrank – replacement of the nut	
Supersedes : N/A

ATA : 271

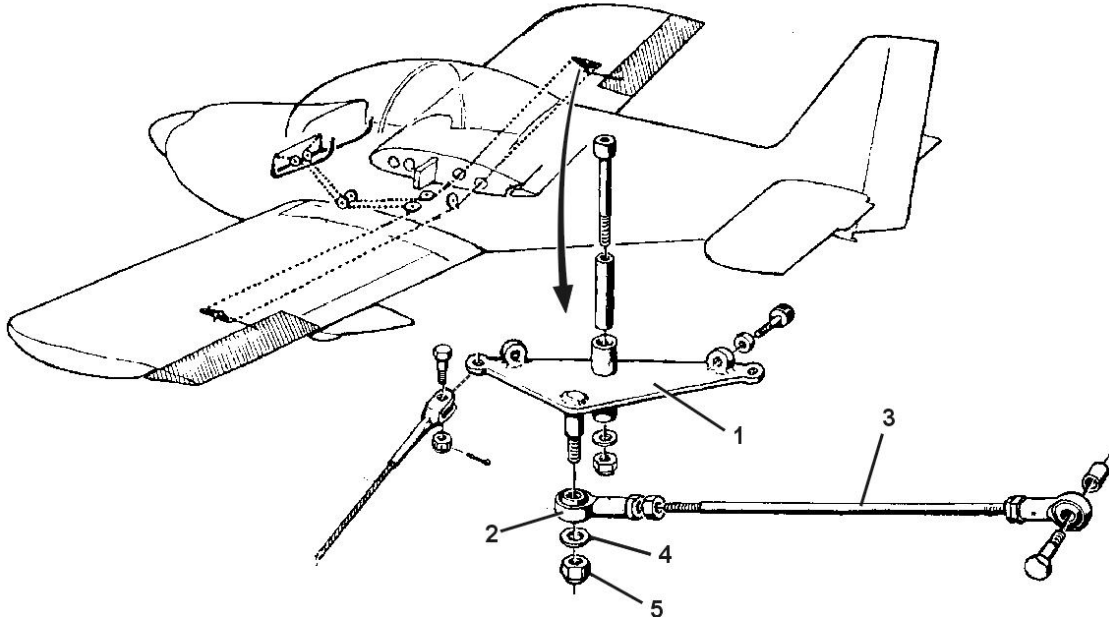
The aileron rod (item 3) is attached to the aileron bellcrank (item 1) by means of:

- a rod end bearing (item 2) ;
- a washer (item 4) ;
- and a nut (item 5).

The attachment using Askubal rod end bearing (mounting 2) does not allow enough safety screw threads coming out to properly lock the nut.

In case of not enough safety screw threads coming out, this SB recommends to install a thin nut 8TA10BE (and to remove the washer when mounting the Askubal rod end bearing).

- a) Measure the thickness of the rod end bearing. If the thickness is:
 - superior or equal to 12 mm (0.47 in) (Askubal rod end bearing), the washer is to be removed.
 - inferior to 12 mm (0.47 in) (Sarma rod end bearing), the washer is to be added.

- b) If necessary (§3a), put the washer in place.
- c) Replace Nylstop nut 8PA106 by nut 8TA10BE.
- d) Screw the nut and tighten moderately (1.2 to 1.5 daN.m) (106 to 133 lbf.in).
- e) Check the number of threads coming out from Nylstop nut. There must be a minimum of one thread and a half (1.5 thread).
- f) Check that the aileron control responds normally to the movements of the stick.
