# ROBIN AVIATION

## SERVICE BULLETIN N°169

**SUBJECT:** BRAKE FLUID RESERVOIR CAP (ATA 32-40)

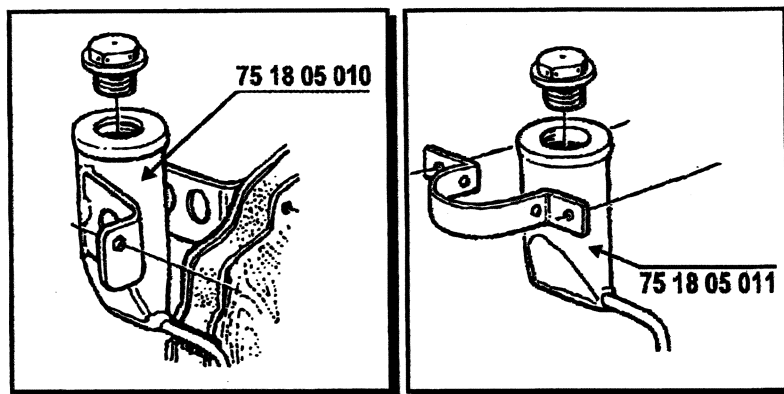
Remove the engine top cowling to ascertain which type of brake fluid reservoir is fitted. The models concerned by this Service Bulletin and referenced above are made of aluminium with brass caps (see sketch below).

The cap should be vented via its top surface.

- 3.1 If the cap has a vent hole simply check that it is not blocked.
- 3.2 If the cap does not have a vent hole:
- For all aircraft except R2000, drill a 1.5 mm through hole through the centre of the cap. Remove any burrs.
  - For R2000 aircraft: replace the existing cap with a cap PN 75.18.05.110.

Tighten by hand only and secure with stainless steel safety wire in accordance with the rules of the art.
