SERVICE BULLETIN

AA-SB-27-005

Link Rod Wear – Inspection & Maintenance

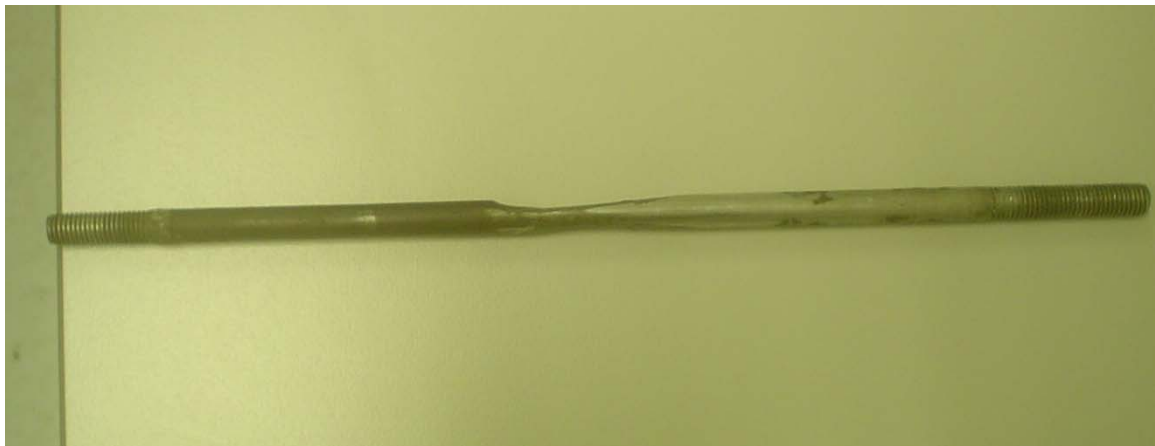
A maintenance organization has reported an instance where a nose gear steering link rod P/N 47.23.01.010 snapped while installing and tensioning new rudder cables. The cause for the failure was found to be due to excessive wear of the link rods over an extended period in service.

After some time in service, the nose gear steering link rods may be excessively worn, failure of which may cause loss of steering and potential landing gear collapse on landing.

- Remove P/N 47.23.01.000 Guide, link rod, LH and RH, with P/N 47.23.01.010 Link rod, pedals to front wheel, LH and RH.
- Inspect steering linkage components for excessive wear.
- Any components with excessive wear should be replaced.
- In the case of the link rod, any diameter measurement (in any direction) more than 0.032" below nominal diameter is not acceptable to return to service.
- Clean and Lubricate with Aeroshell 6 or equivalent grease before re-assembly.
- Repeat this inspection every 2000 hrs in service or every 10 years whichever occurs first.

Clean and Inspect all components of the steering rod assembly for wear and damage. Replace worn and damaged parts. Maximum permissible wear for return to service of the steering link rod is 0.032" (0.8mm) reduction in diameter in any position or direction.
