SERVICE BULLETIN

AA-SB-71-004

Engine Mount Inspection and Repair

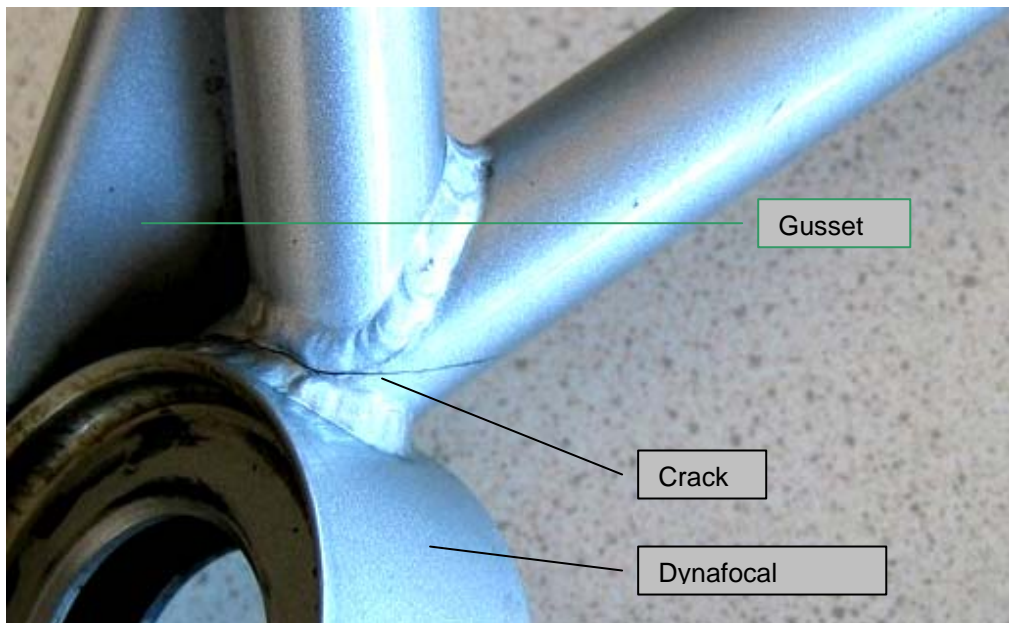
Figure 1: Cracked engine Mount Tube

Two cases has been reported of cracked engine mount frames. Both occurred in Alpha manufactured R2160 aircraft. The repair scheme is applicable to all models in the R2000 range, if similar cracks are found in other models.

Cracks has been reported in the tubes near the RH upper engine mount bobbin. (See Figure 1).

Within the next 10 flying hours, carry out a thorough visual inspection of the engine mount frame tubes near the welds. In the reported cases cracks were found in the tubes near the RH upper Dynafocal mount.
